## Installation Details

**Location:** A car engine manufacturing factory, Hyundai Motor Ulsan

**Area:** A cold water circulation pipeline for the cooling tower and the induction hardening machine

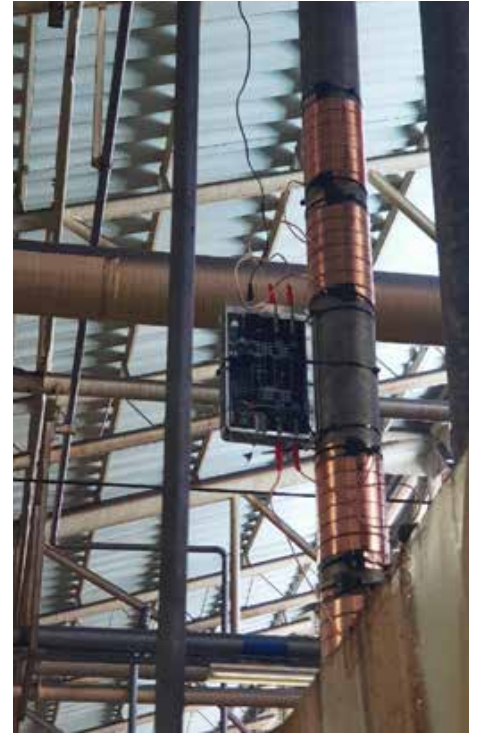
Vulcan S25 was installed around 50 meter before the induction hardening machine.

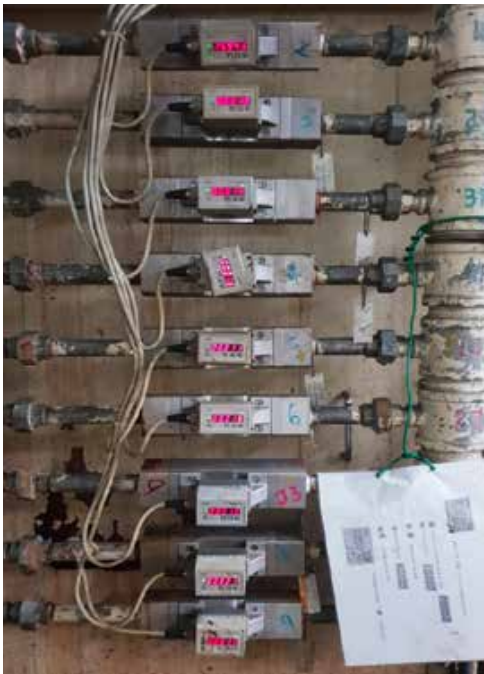
There are 9 secondary small pipes with water meters. These meters were installed to make sure a stable flow rate. If the flow rate goes down, it would cause a problem of the induction hardening machine. Therefore, the pipes had to be cleaned manually every 2-3 months.

1. Scale problems in the pipelines and the induction hardening machine.
2. There are 9 secondary small pipes, they had to be cleaned manually every 2-3 months.

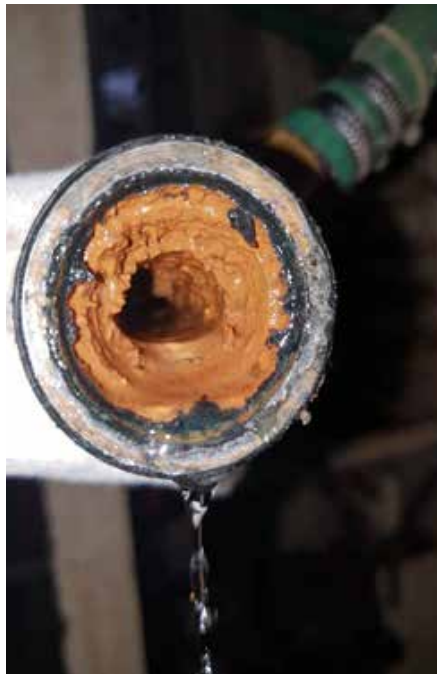
**First inspection:** May 21, 2018.

Inside of a secondary small pipe, before Vulcan S25 was installed.

Note: scale was not manually removed before the Vulcan was fitted on source pipe (see photo).

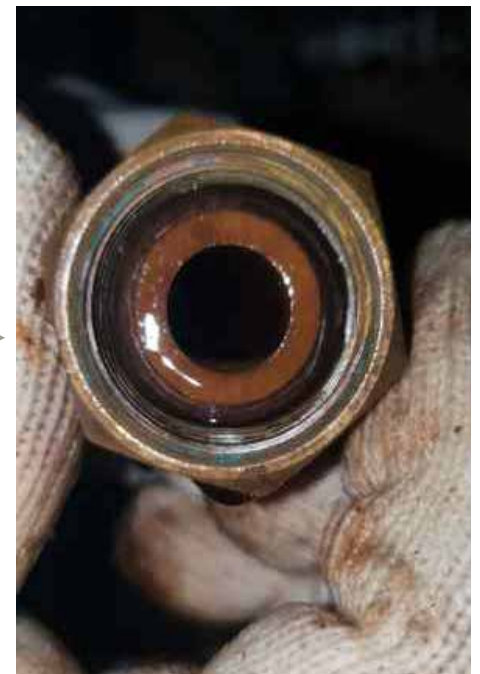
**Last inspection:** November 21, 2018.

After 6 months with Vulcan treatment: the pipe is free of scale.

2. After Vulcan S25 had been installed for 6 months, the secondary pipes were opened: scale that had been left in piping had disappeared and all 9 secondary pipes had become clean (see photo).
